ANNUAL REPORT FOR 2004

Key Branch Mitigation Site
Anson County
WBS Element 34398.4.1
TIP No. R-2239WM

Prepared By:
Office of Natural Environment & Roadside Environmental Unit
North Carolina Department of Transportation
March 2005

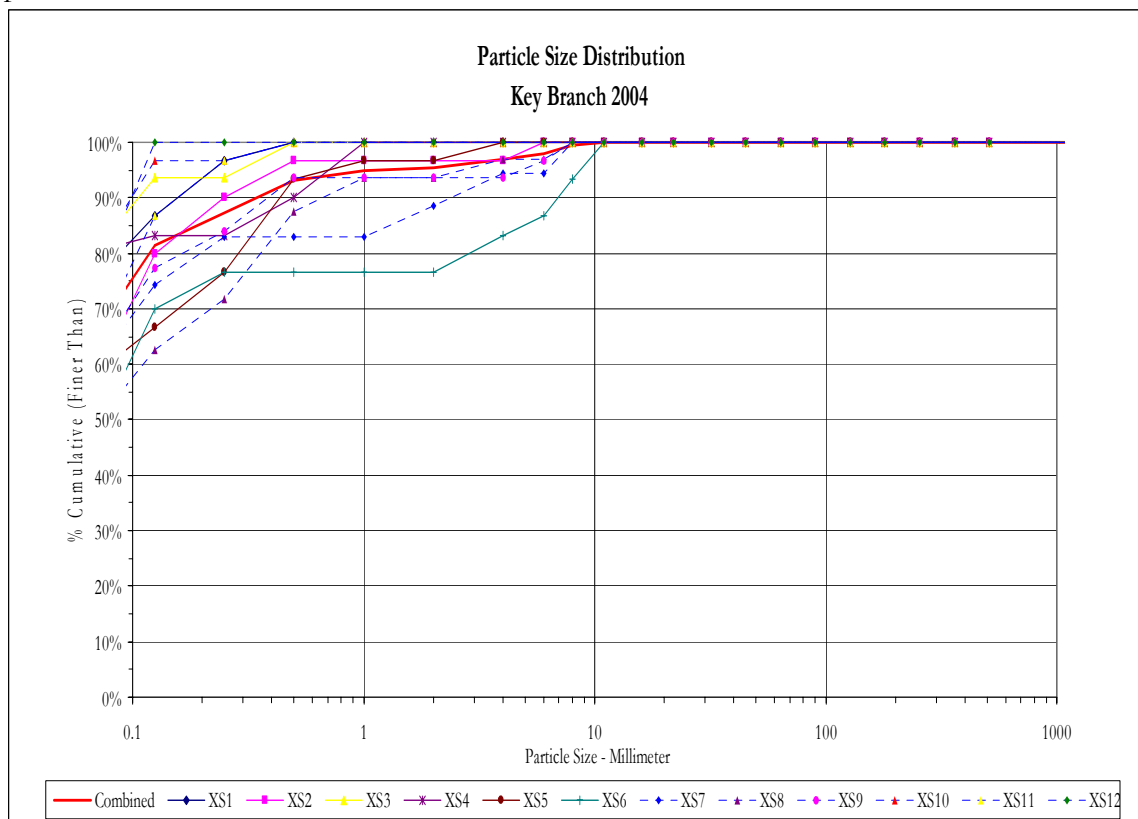
Pebble counts were taken at each cross section as a means to determine the bed material at each cross section location. However, only pebble counts taken at riffle sections can be utilized to classify the stream. The pebble counts taken during the Year 2004 monitoring period noted that the D_{50} (50 percent of the sampled population is equal to or finer than the representative particle diameter) for the riffle sections of Key Branch was less than 0.062 mm approximately, which is indicative of a silt/clay-bed stream.

A chart depicting the particle size distributions for Key Branch for the Year 2004 is presented below.

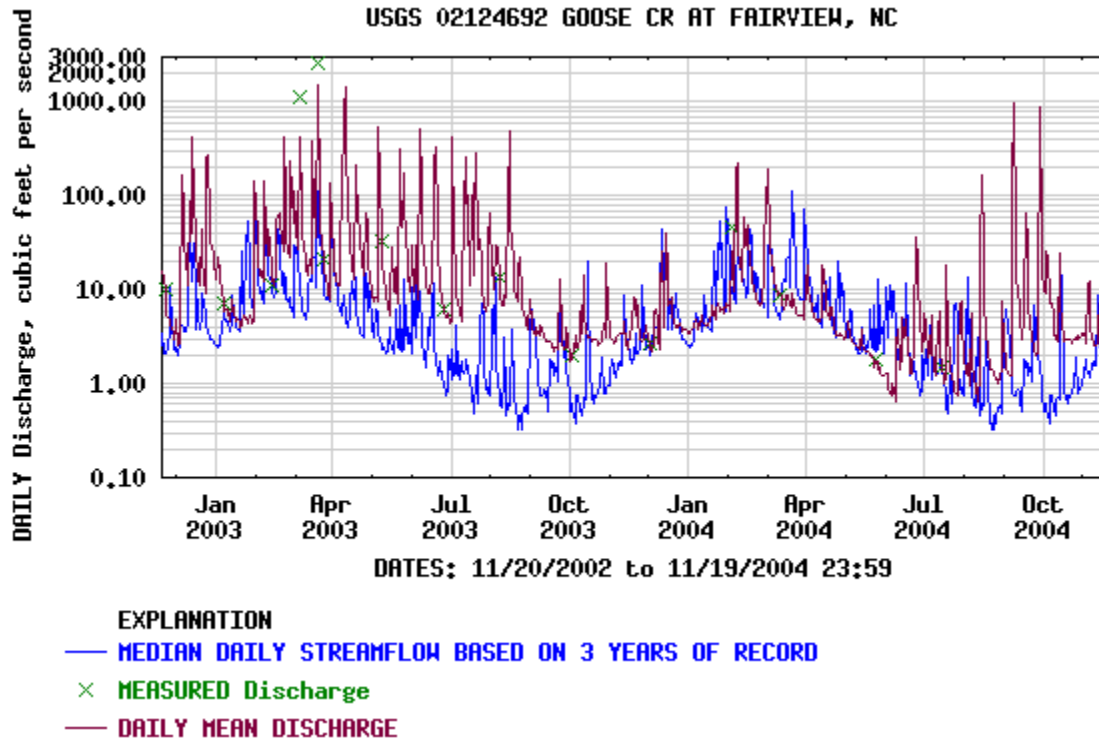
The Goose Creek gage was utilized for this report since it is the closest and most comparable active gage station located in the Yadkin-Pee Dee River Basin. The Goose Creek Gaging Station has a drainage area of 24 square miles. It is situated in USGS Hydrologic Unit 03040105. Datum of the gage is 460.0 feet above sea level NGVD29. Based on the drainage area associated with the gage, the correlated bankfull discharge according to the NC Rural Piedmont Regional Curves (USACE, 2003) is approximately 900 cubic feet per second (cfs). A review of peak flows was conducted for the period between November 2002 and November 2004. According to the graph, there were three bankfull events that occurred during this period, one of which was in September 2004. The USGS graph depicting these peak flows is presented below.

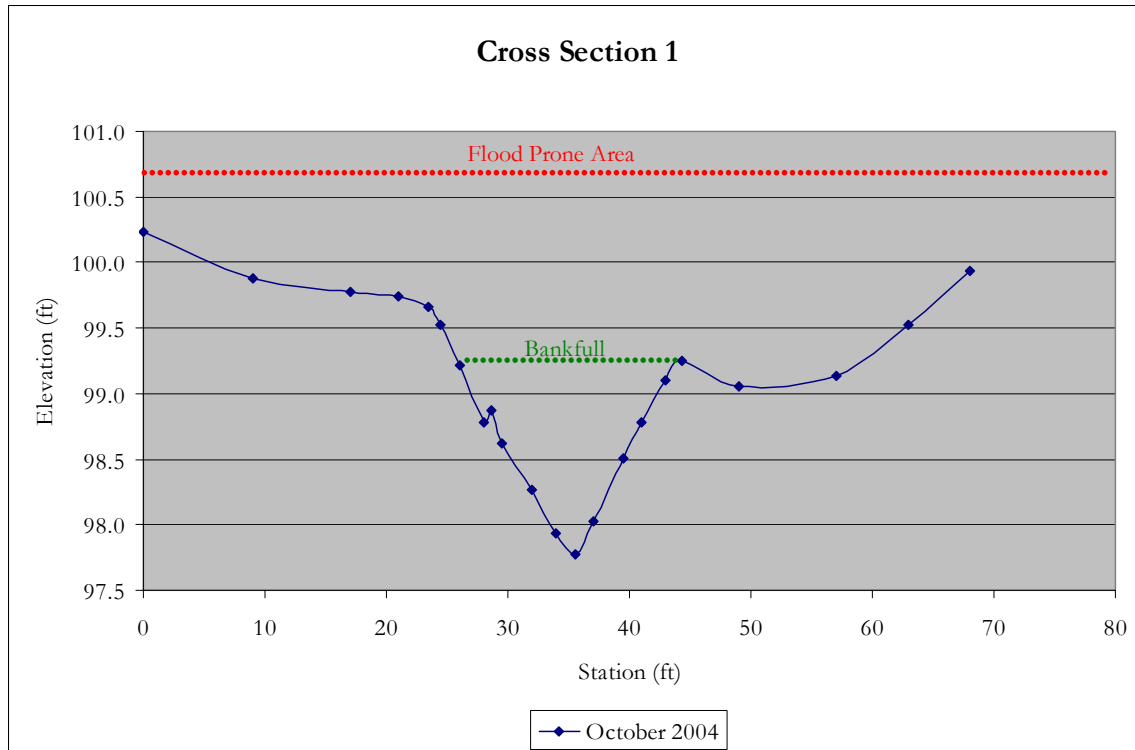
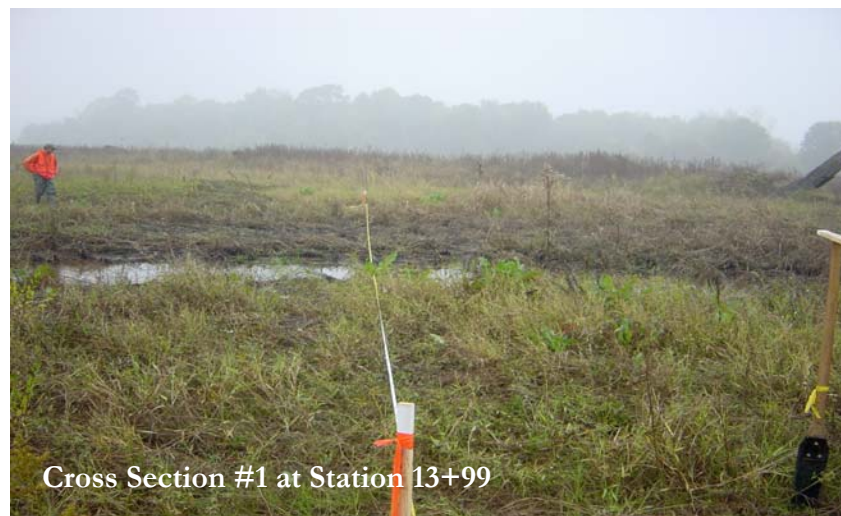
Cross-Section #1 (Glide) Abbreviated Morphological Summary

2004	2005	2006	2007	2008
Bankfull Cross Sectional Area (ft ²)	13.0				
Maximum Bankfull Depth (ft)	1.5				
Width of the Floodprone Area (ft)	150				
Bankfull Mean Depth (ft)	0.7				
Width/Depth Ratio	26.6				
Entrenchment Ratio	>5				
Bankfull Width (ft)	18.6

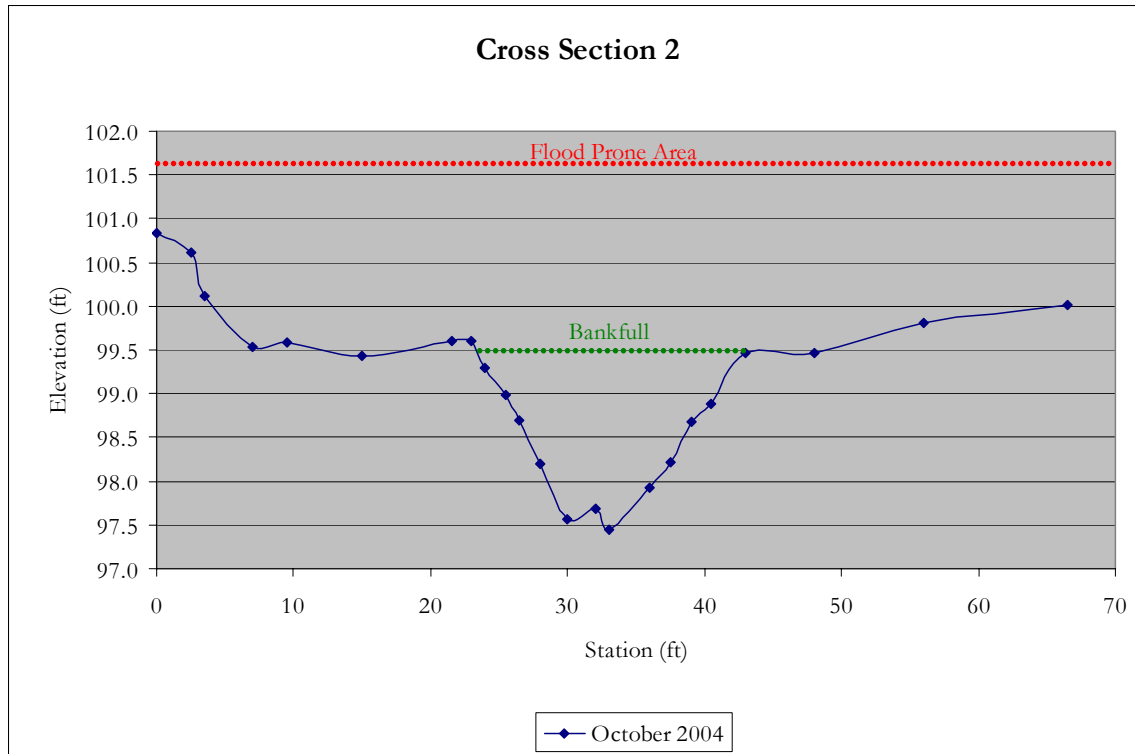
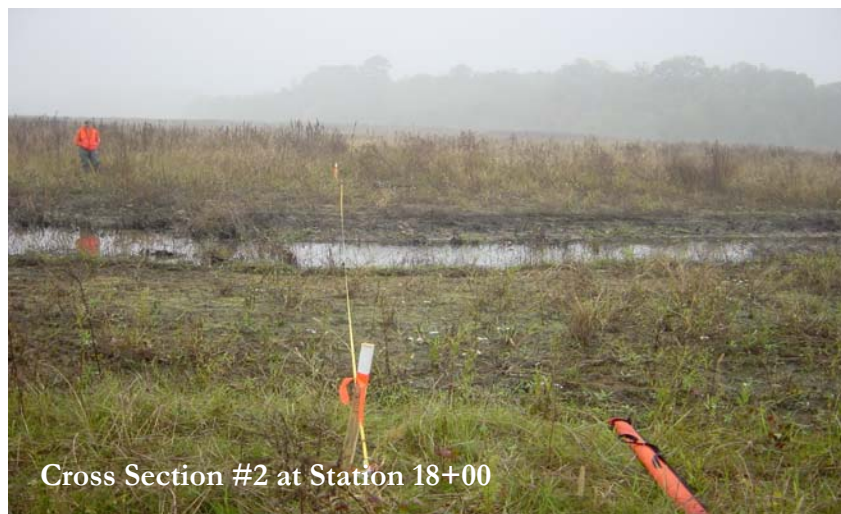
Cross-Section #2 (Run) Abbreviated Morphological Summary

2004	2005	2006	2007	2008
Bankfull Cross Sectional Area (ft ²)	22.2				
Maximum Bankfull Depth (ft)	2.0				
Width of the Floodprone Area (ft)	150				
Bankfull Mean Depth (ft)	1.1				
Width/Depth Ratio	18.4				
Entrenchment Ratio	>5				
Bankfull Width (ft)	20.2

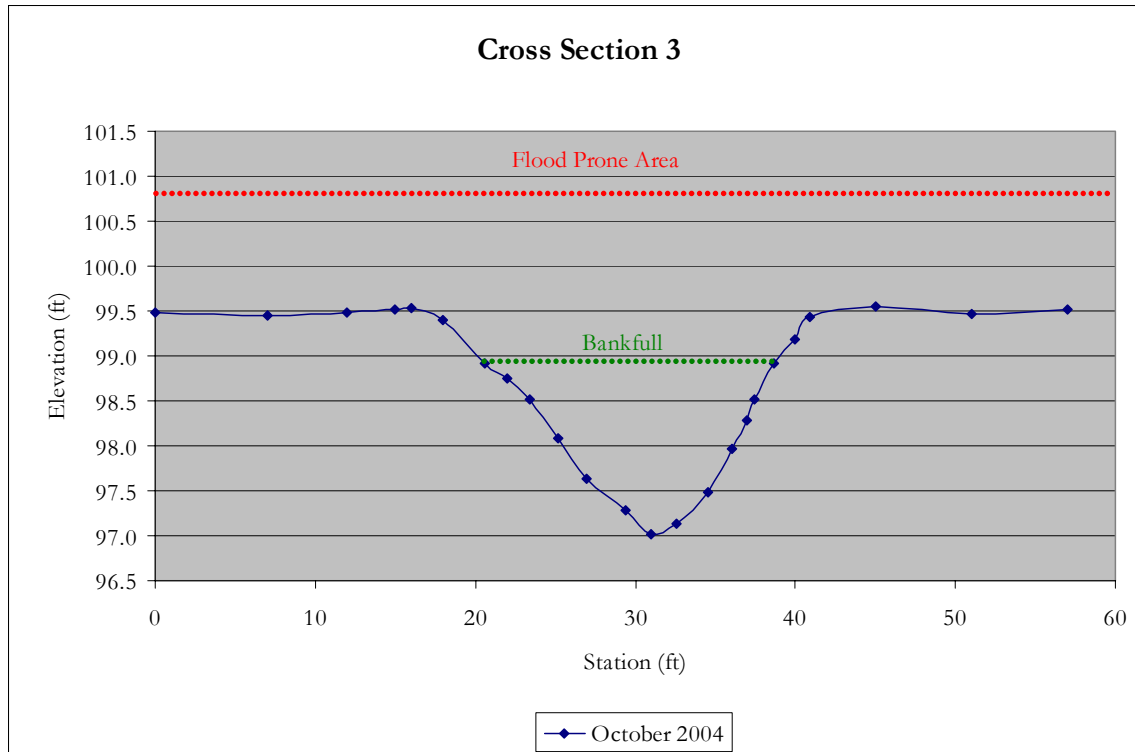
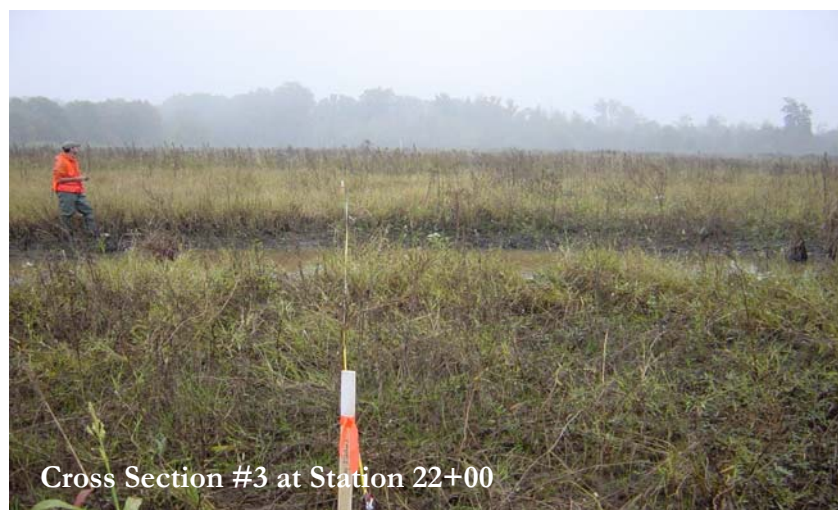
Cross-Section #3 (Pool) Abbreviated Morphological Summary

2004	2005	2006	2007	2008
Bankfull Cross Sectional Area (ft ²)	18.1				
Maximum Bankfull Depth (ft)	1.9				
Width of the Floodprone Area (ft)	150				
Bankfull Mean Depth (ft)	1.0				
Width/Depth Ratio	18.1				
Entrenchment Ratio	>5				
Bankfull Width (ft)	18.1

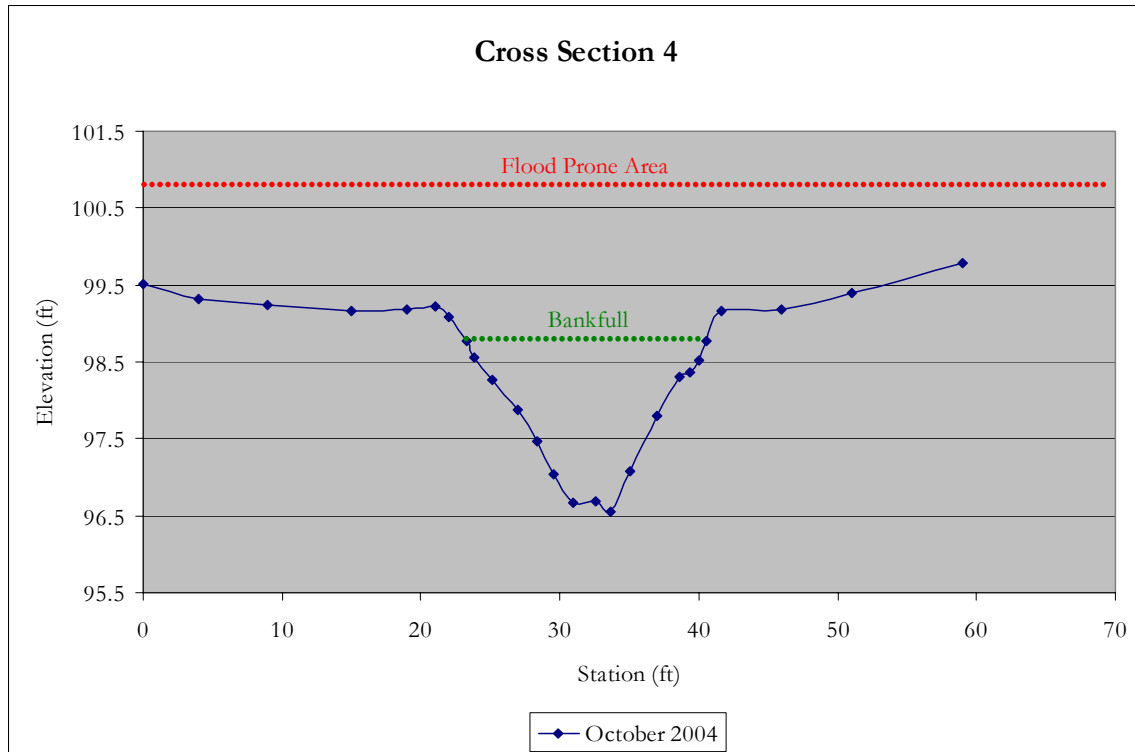
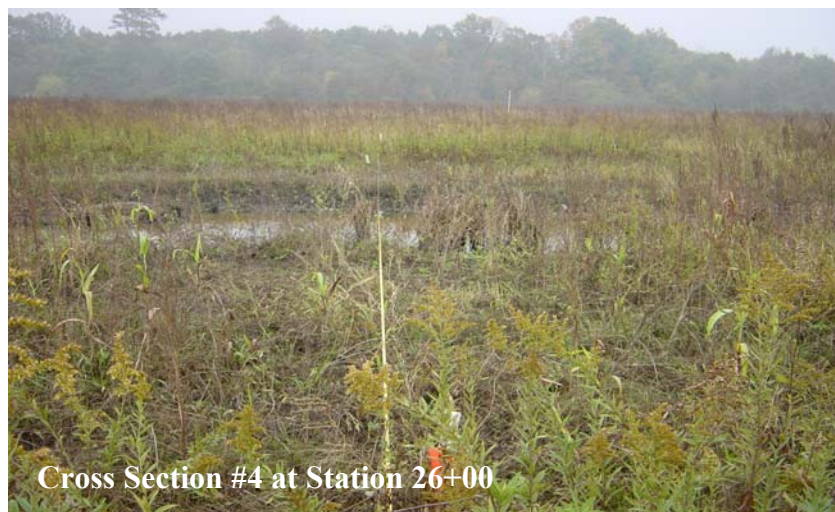
Cross-Section #4 (Pool) Abbreviated Morphological Summary

2004	2005	2006	2007	2008
Bankfull Cross Sectional Area (ft ²)	20.8				
Maximum Bankfull Depth (ft)	2.2				
Width of the Floodprone Area (ft)	150				
Bankfull Mean Depth (ft)	1.2				
Width/Depth Ratio	14.4				
Entrenchment Ratio	>5				
Bankfull Width (ft)	17.3

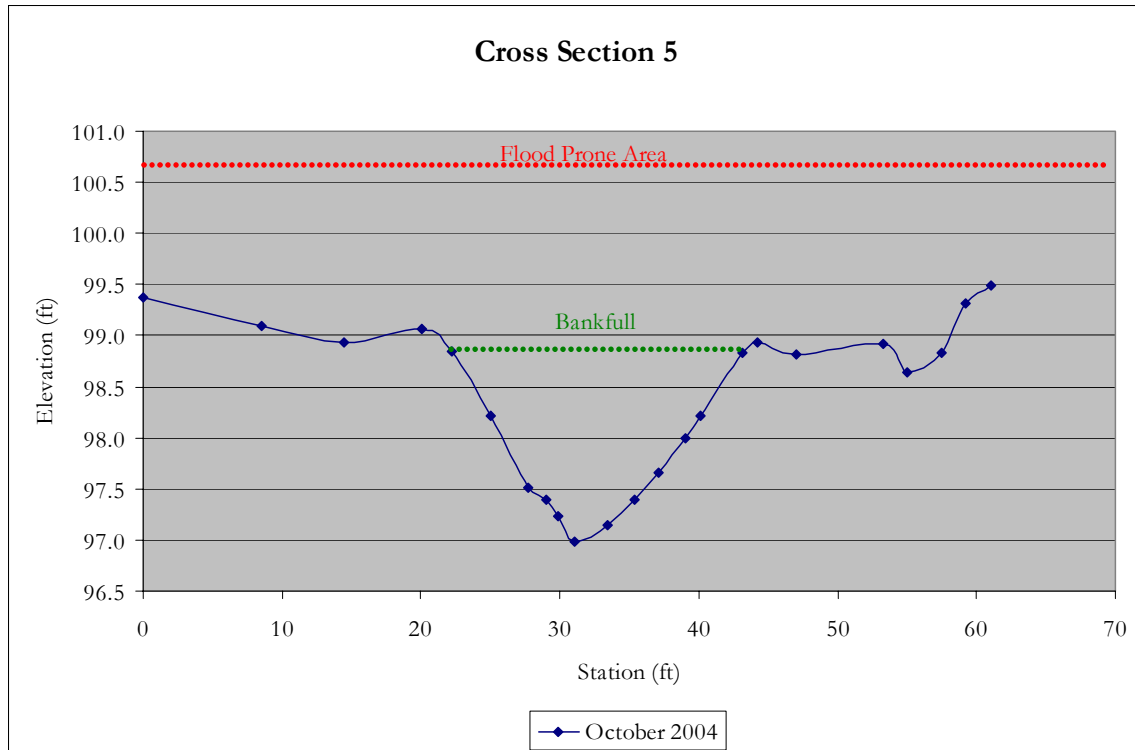
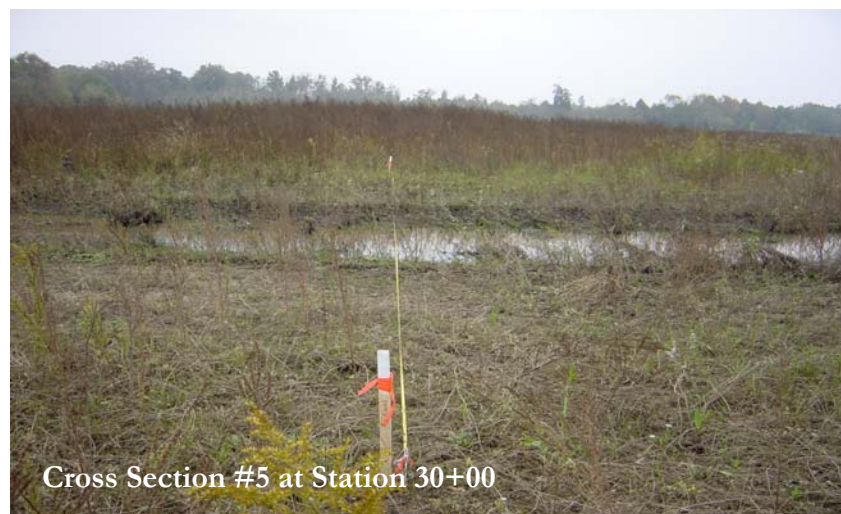
Cross-Section #5 (Riffle) Abbreviated Morphological Summary

2004	2005	2006	2007	2008
Bankfull Cross Sectional Area (ft ²)	20.9				
Maximum Bankfull Depth (ft)	1.8				
Width of the Floodprone Area (ft)	150				
Bankfull Mean Depth (ft)	1.0				
Width/Depth Ratio	20.9				
Entrenchment Ratio	>5				
Bankfull Width (ft)	20.9

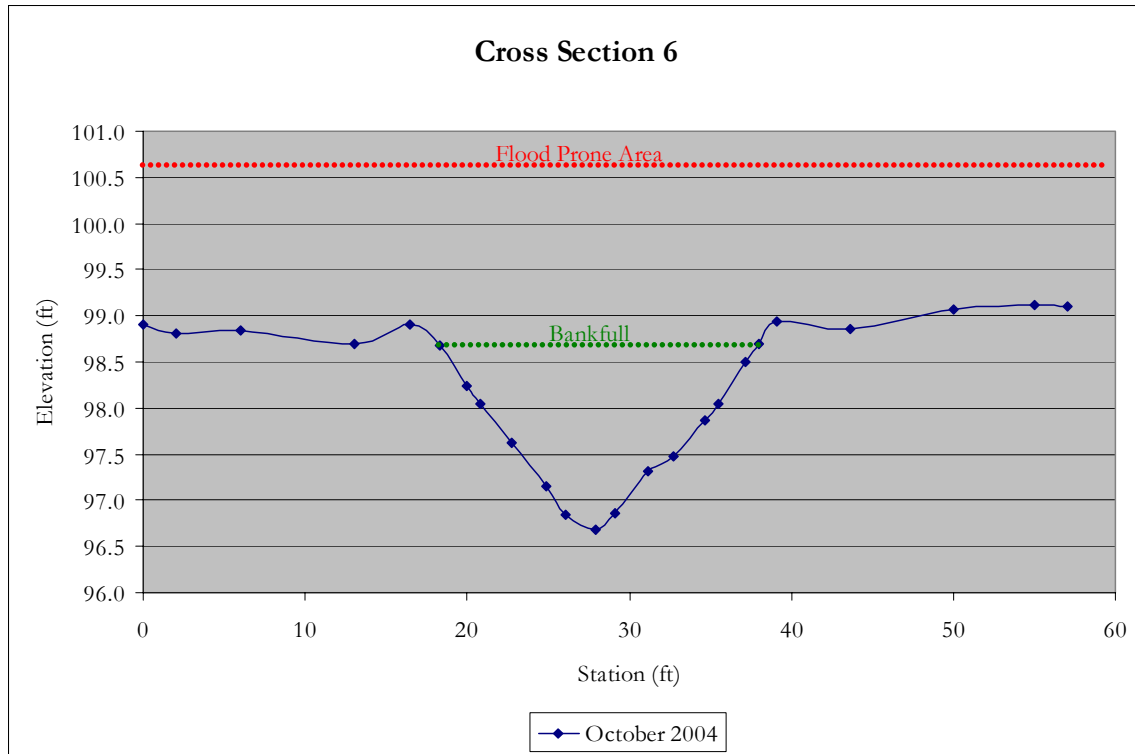
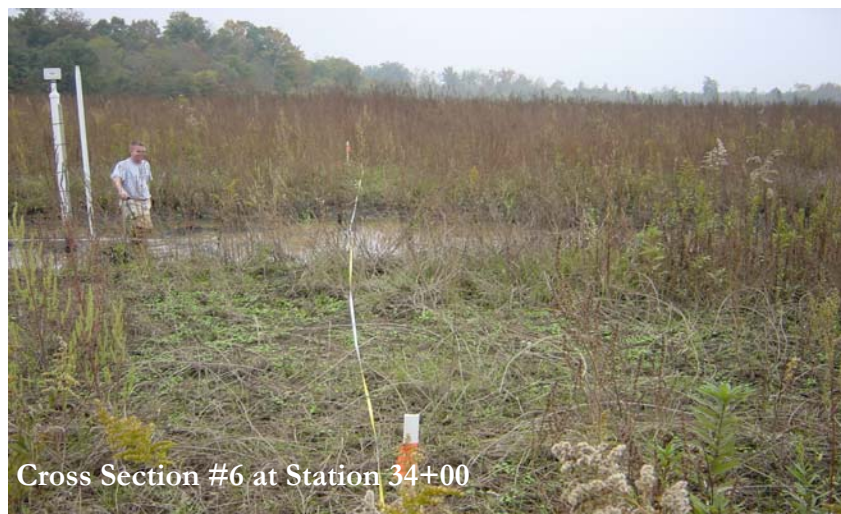
Cross-Section #6 (Glide) Abbreviated Morphological Summary

2004	2005	2006	2007	2008
Bankfull Cross Sectional Area (ft ²)	21.7				
Maximum Bankfull Depth (ft)	2.0				
Width of the Floodprone Area (ft)	150				
Bankfull Mean Depth (ft)	1.1				
Width/Depth Ratio	17.9				
Entrenchment Ratio	>5				
Bankfull Width (ft)	19.7

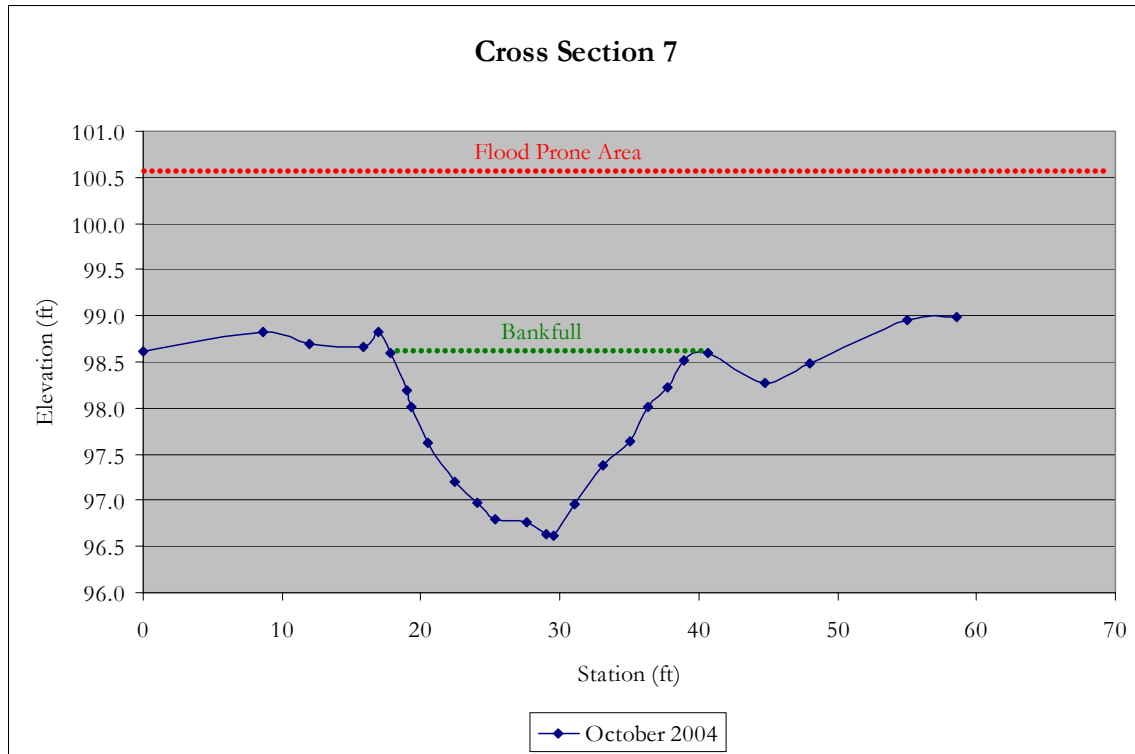
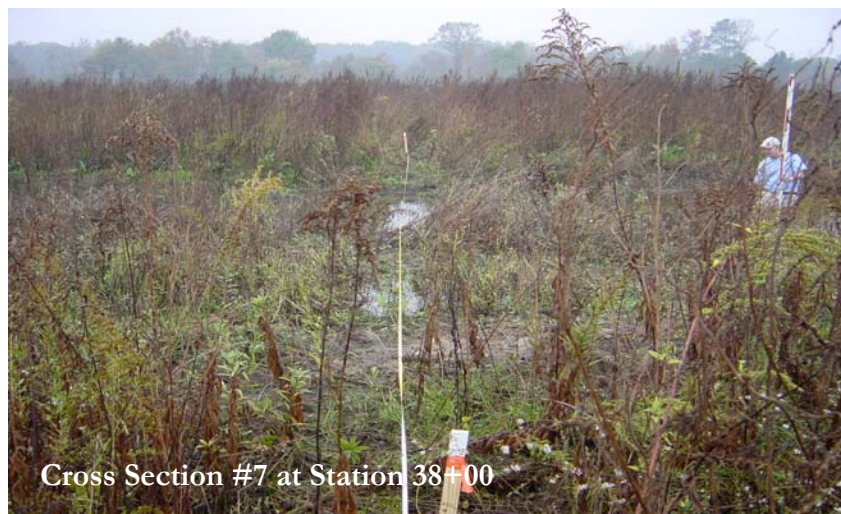
Cross-Section #7 (Run) Abbreviated Morphological Summary

2004	2005	2006	2007	2008
Bankfull Cross Sectional Area (ft ²)	25.2				
Maximum Bankfull Depth (ft)	2.0				
Width of the Floodprone Area (ft)	150				
Bankfull Mean Depth (ft)	1.1				
Width/Depth Ratio	20.8				
Entrenchment Ratio	>5				
Bankfull Width (ft)	22.9

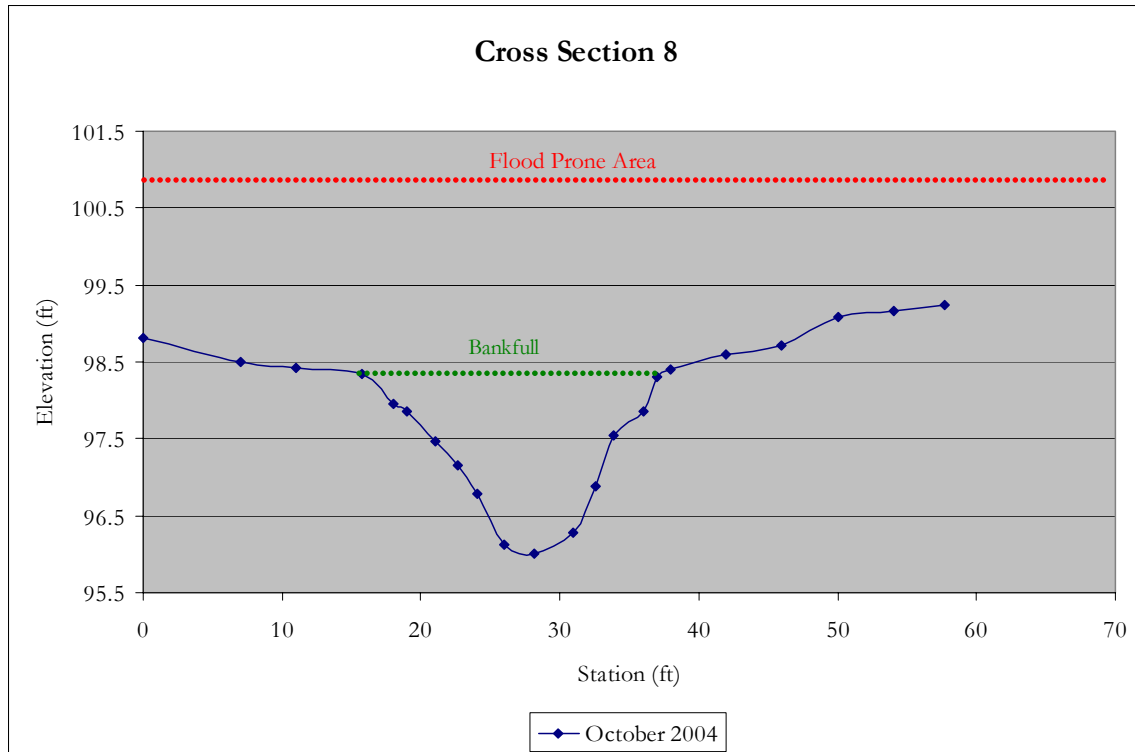
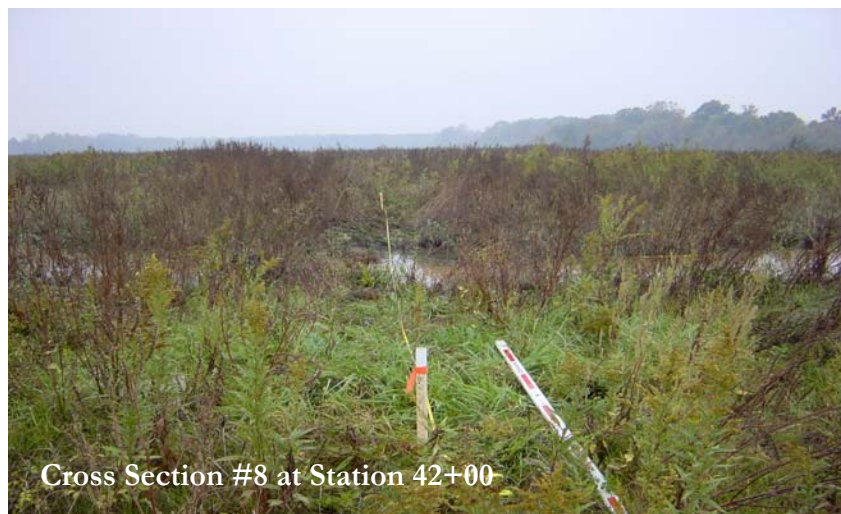
Cross-Section #8 (Pool) Abbreviated Morphological Summary

2004	2005	2006	2007	2008
Bankfull Cross Sectional Area (ft ²)	25.9				
Maximum Bankfull Depth (ft)	2.3				
Width of the Floodprone Area (ft)	150				
Bankfull Mean Depth (ft)	1.2				
Width/Depth Ratio	18.0				
Entrenchment Ratio	>5				
Bankfull Width (ft)	21.6

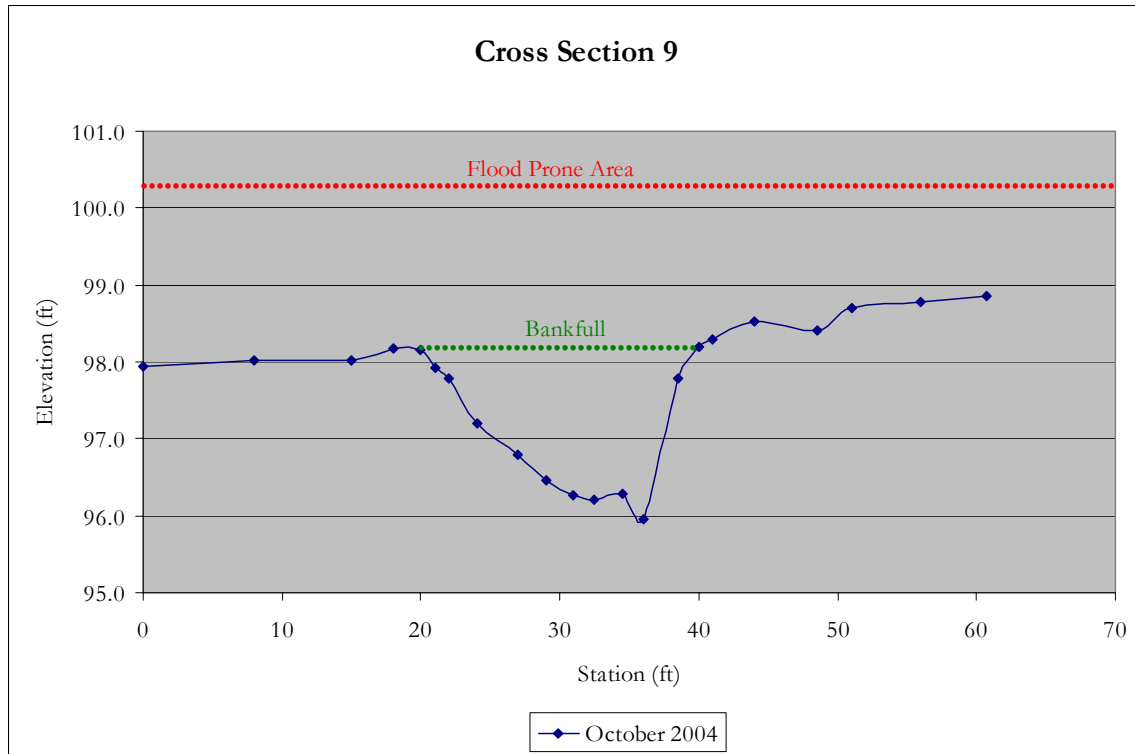
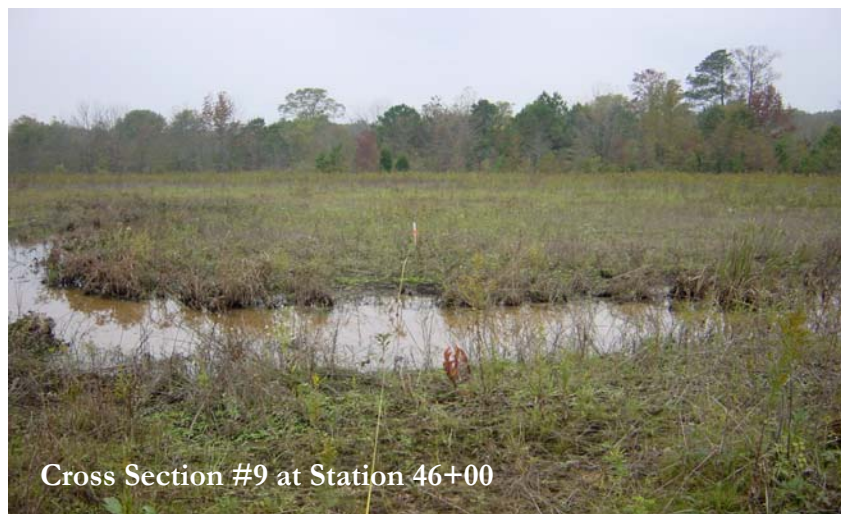
Cross-Section #9 (Glide) Abbreviated Morphological Summary

2004	2005	2006	2007	2008
Bankfull Cross Sectional Area (ft ²)	26.0				
Maximum Bankfull Depth (ft)	2.2				
Width of the Floodprone Area (ft)	150				
Bankfull Mean Depth (ft)	1.3				
Width/Depth Ratio	15.4				
Entrenchment Ratio	>5				
Bankfull Width (ft)	20.0

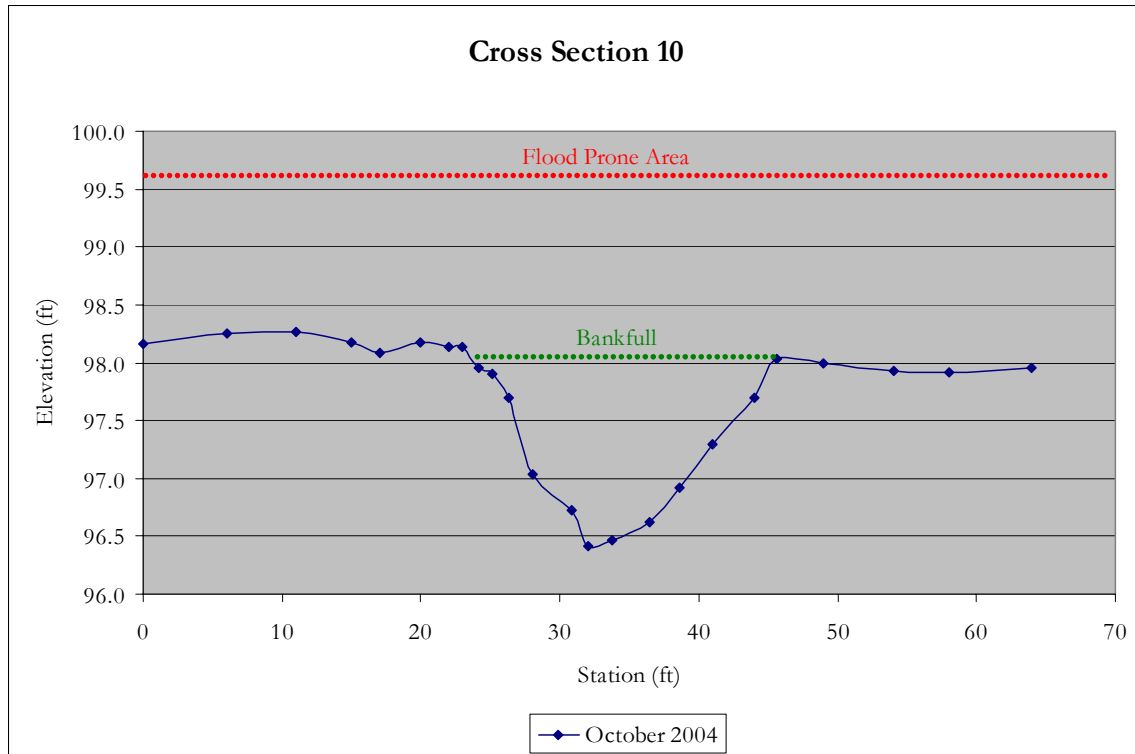
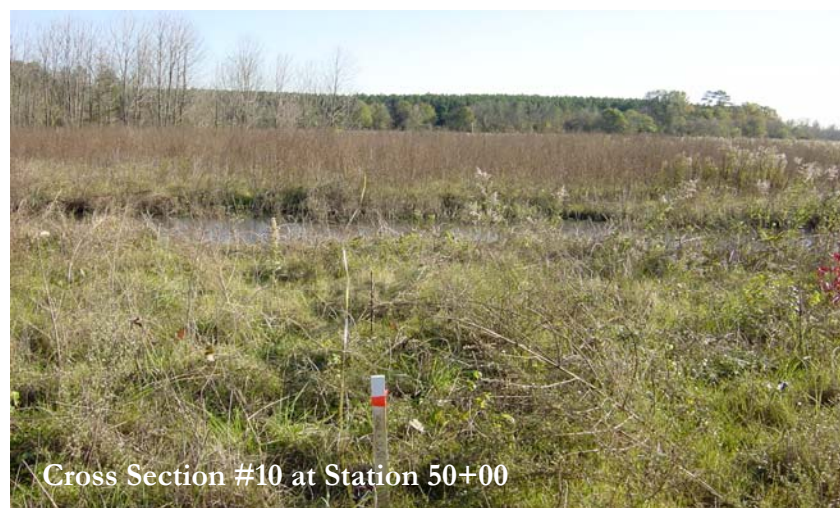
Cross-Section #10 (Rifle/Run) Abbreviated Morphological Summary

2004	2005	2006	2007	2008
Bankfull Cross Sectional Area (ft ²)	19.0				
Maximum Bankfull Depth (ft)	1.6				
Width of the Floodprone Area (ft)	150				
Bankfull Mean Depth (ft)	0.9				
Width/Depth Ratio	23.4				
Entrenchment Ratio	>5				
Bankfull Width (ft)	21.1

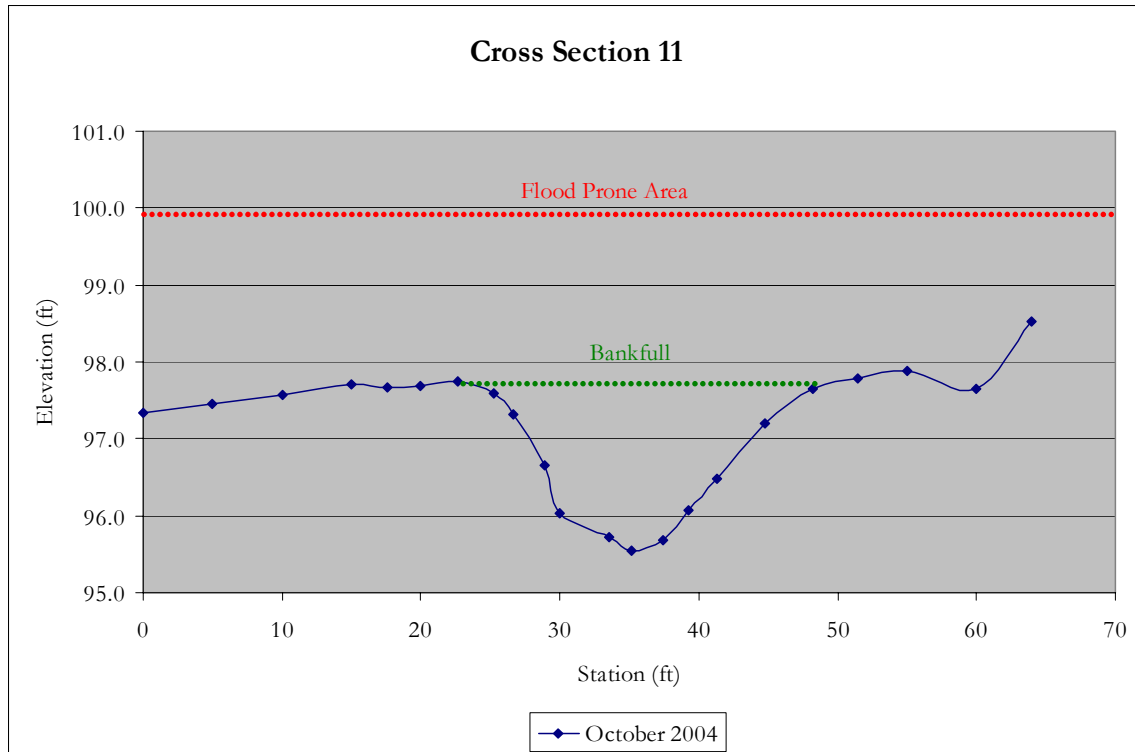
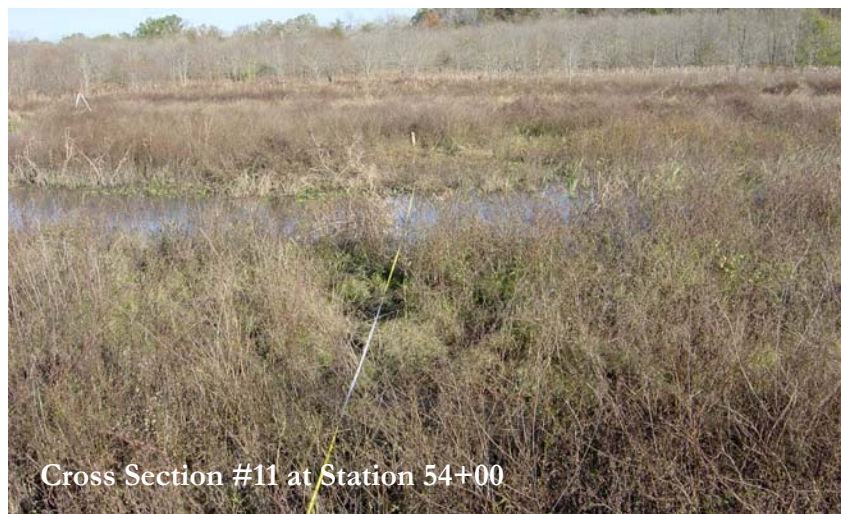
Cross-Section #11 (Run) Abbreviated Morphological Summary

2004	2005	2006	2007	2008
Bankfull Cross Sectional Area (ft ²)	30.4				
Maximum Bankfull Depth (ft)	2.2				
Width of the Floodprone Area (ft)	150				
Bankfull Mean Depth (ft)	1.1				
Width/Depth Ratio	25.1				
Entrenchment Ratio	>5				
Bankfull Width (ft)	27.6

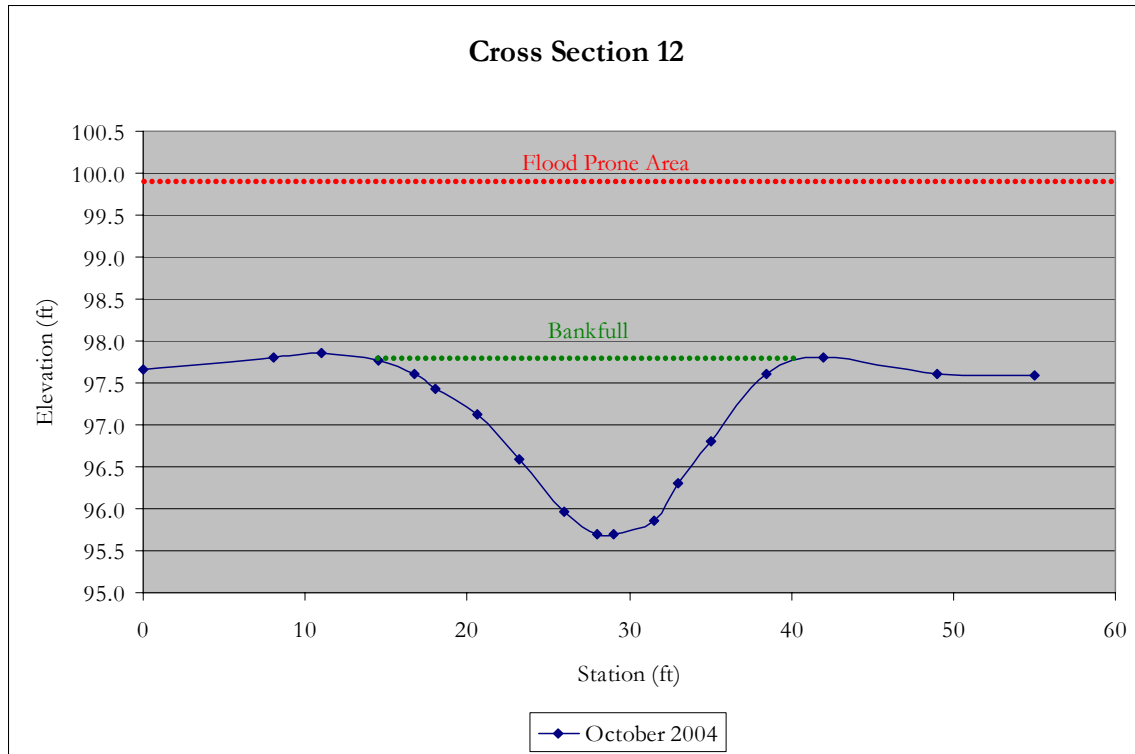
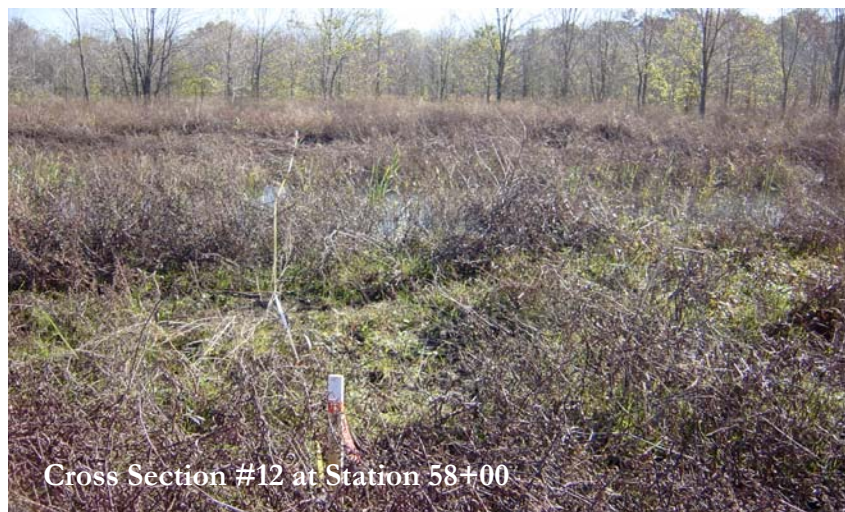
Cross-Section #12 (Rifle) Abbreviated Morphological Summary

2004	2005	2006	2007	2008
Bankfull Cross Sectional Area (ft ²)	26.9				
Maximum Bankfull Depth (ft)	2.1				
Width of the Floodprone Area (ft)	150				
Bankfull Mean Depth (ft)	1.0				
Width/Depth Ratio	26.9				
Entrenchment Ratio	>5				
Bankfull Width (ft)	26.9

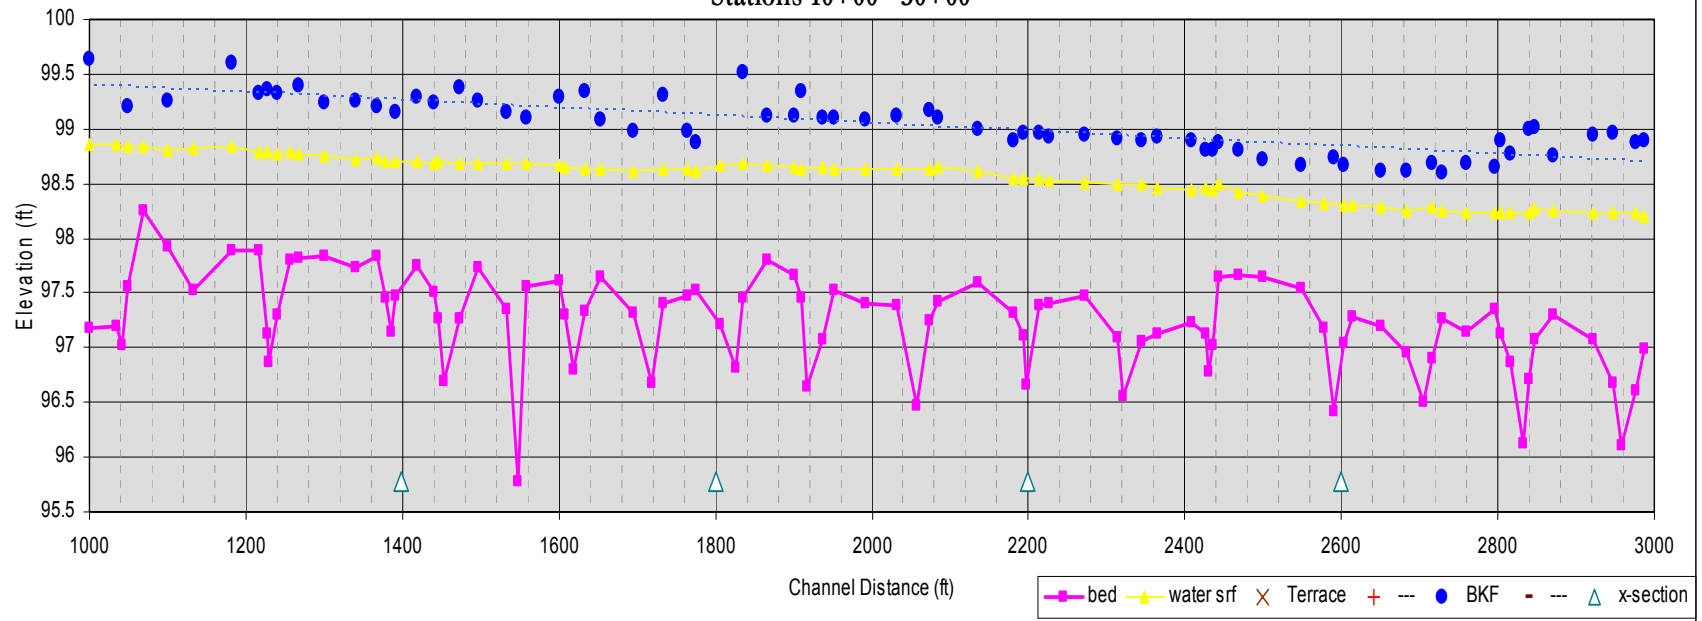
Key Branch Longitudinal Profile 2004
Stations 10+00 - 30+00

A longitudinal profile survey was conducted along Key Branch. Bank stability and overall condition of the site were assessed during the cross section and longitudinal profile surveys. Three areas of concern were observed in 2004. Descriptions and evaluations of these areas are as follows:

- ◆ A beaver impoundment (approximately 150 feet from the end of the site) has caused a large pond to form at the lower end of the reach. The impoundment has also

caused water to back up throughout the reach. The high water level has resulted in the stream not functioning according to designs.
